Active Errata List

Radiation Tolerant FIFOs

M67206F M672061F M67204F Errata Sheet

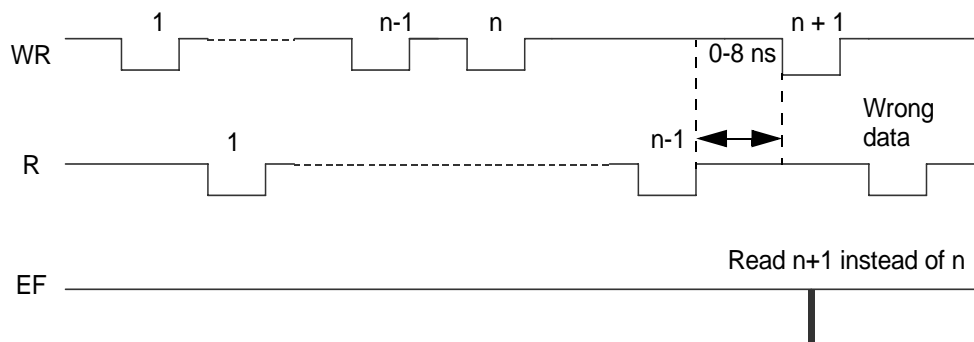
Figure 1. Behavior Description

Rising edge of READ from 0 ns up to 8 ns (typical) before the falling edge of WRITE when only one data is left to read.

Empty flag glitch and following data shift out 2nd byte corruption occurs when the rising edge of the first "READ" for data shift out occurs before falling edge of the third "WRITE" for data shift in.

between 0 ns and 11 ns

Temperature = 125°C

Voltage = 4.5V

These FIFOs are functional outside of the above timing and data marginal configuration.

The recommended action is to avoid this particular configuration.

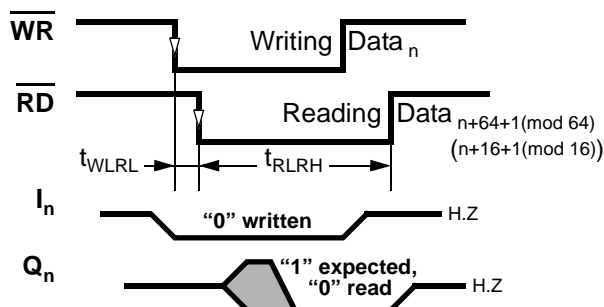
Sometimes a bit that has been written "1" is read "0".

1. Read and write commands fall down almost at the same time, t_{WLRL} parameter in the hereunder table.
2. Write bit "0" on input port while a bit "1" is expected on output port.
3. Reading the $64^{th}+1 \pmod{64}$ ($16^{th}+1 \pmod{16}$ for 4Kx9 FIFO) vs. the writing location.
4. Read pulse (t_{RLRH}) less than the one specified in the hereunder table.

The memory array of the 16Kx9 FIFO contains 64 columns, the 4Kx9 contains 16 columns. To reduce the read access time, a pipe line has been implemented on the data path. When the $data_n$ is going out of the FIFO, the $data_{n+1}$ is pre-fetched for the next read access. When the internal writing and reading are different from $64 \pmod{64}$ ($16 \pmod{16}$), a write and a read access are made on the same column. Coupling between the read bit-line and the write bit-line only disturbs the pre-fetch operation, forcing the sense amplifier to output "0". Then, the next external reading may be wrong.

t_{WLRL}		t_{RLRH}
	minimum	maximum	
67206H / 672061H	≥ 0 ns	≤ 8 ns	≤ 30 ns
67204H	≥ -2 ns	≤ 8 ns	≤ 25 ns

1. No read sequence while write sequence.
2. Control the gap between the read and write locations
3. Control the t_{WLR} parameter in accordance with the above table.
4. Apply a read pulse t_{RLRH} greater than the value given in the above table.

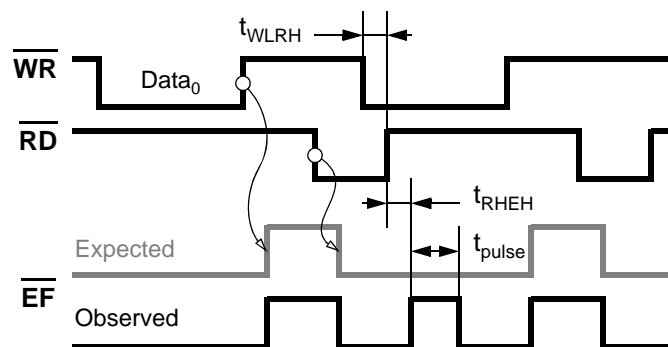
1. \overline{WR} wide pulse width:

A parasitic positive pulse can be observed during a FIFO write if it is applied during the read of first data of the FIFO buffer (c.f. hereunder chronograms).

Un-controlled delays on input signals of a flags logic decoder generate an internal glitch. This glitch is re-formatted by the on-chip ETD system (Edge Transition Detection) and a parasitic pulse is output on \overline{EF} pin.

1. No write sequence while read sequence.
2. \overline{EF} evaluation according to the following characterization.

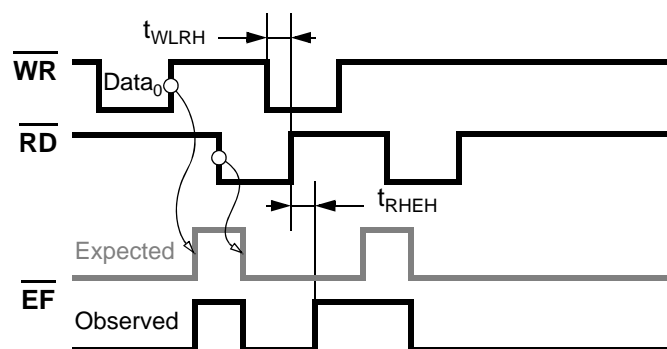
2. \overline{WR} short pulse width:

In this case, the falling edge of the parasitic pulse is masked by the beginning of the regular high level of \overline{EF} flag.
