82559 Fast Ethernet Multifunction PCI/CardBus Controller

Stepping Information

October 2004

Revision 2.2

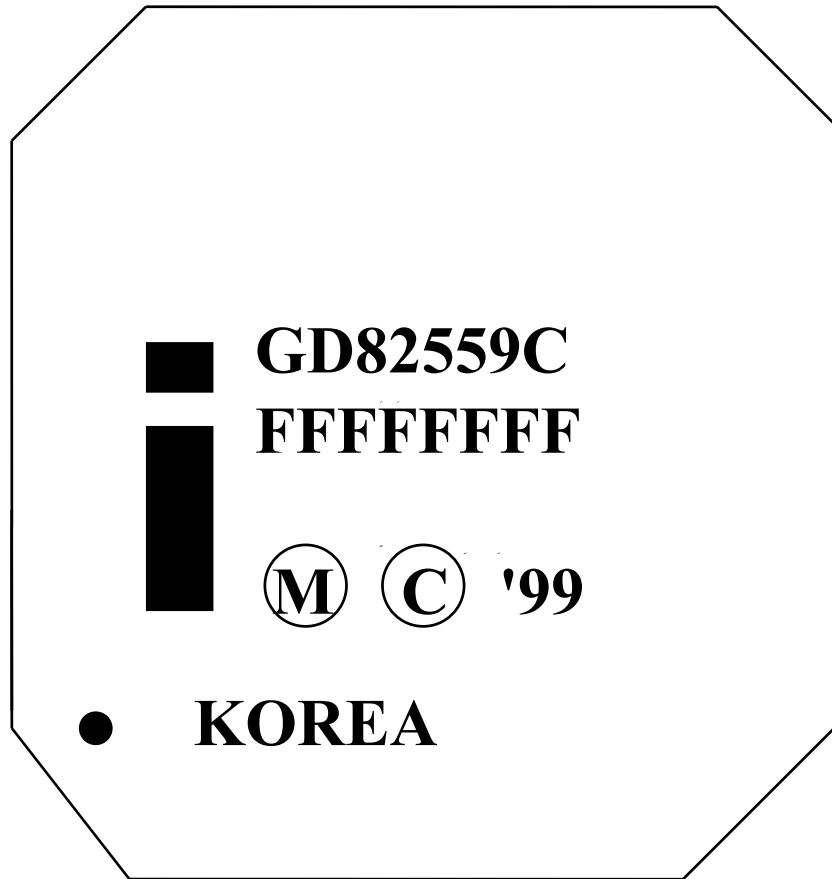
82559 Component Marking Identification

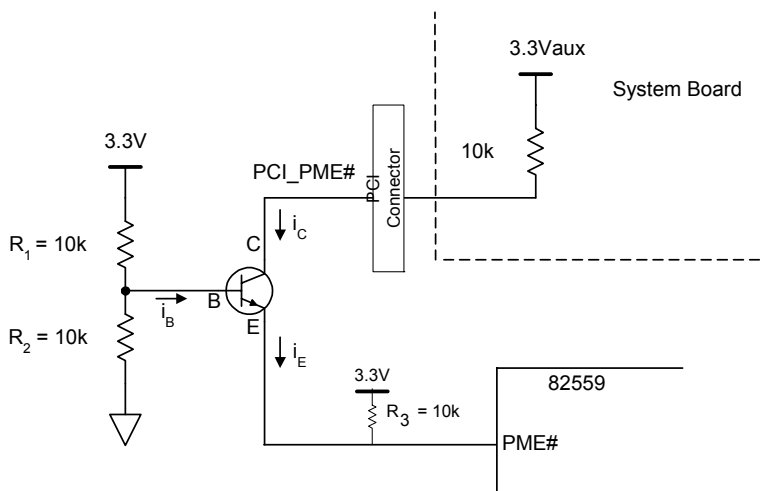
Problem: During power cycle events, the electrostatic discharge (ESD) elements internal to the 82559 may falsely clamp the Power Management Event (PME) output signal to approximately 1.5 volts for 100 ms to 150 ms during initial power up. This can cause wake-up events to be recognized by the system if power management events are enabled in the system chipset. This may result in a problem for mobile environments since the false clamping can cause a suspended system to wake up when the power to the LAN device is transitioned.

Implication: The implications of this anomaly depend on the target system configuration. In desktop and server systems, the impact is limited to a false wake-up event occurring when a new card is installed. In mobile systems where the LAN power is transitioned more frequently, the PME signal should be disabled during transitions.

Workaround: False PME indications can be avoided by disabling the recognition of a PME before removing or restoring power to the 82559. If a hardware solution is required, the following isolation circuit has been proven to be effective. The circuit requires the PCI PME signal (PCI_PME#) to be isolated from the 82559 PME signal (PME#). The system does not see the 1.5 voltage level drop caused by the 82559's power transition.

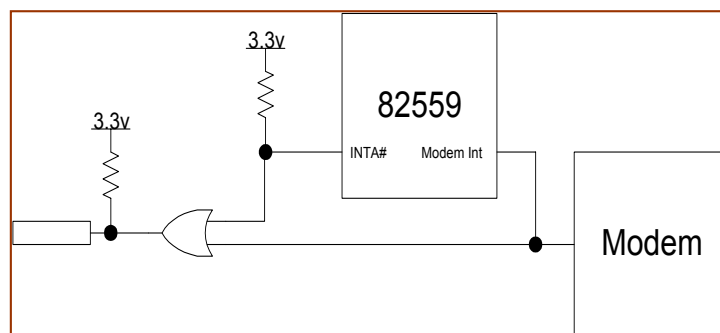
Problem: The propagation of modem interrupts in the 82559C is linked to PCI clock activity. The 82559C local interface enables ISA based modems to operate in a PCI environment. In Advanced Configuration and Power Interface (ACPI) systems, the operating system may place the 82559 in the D3 power state and shut down the PCI clock while the modem is active. This prevents the 82559 from clocking modem interrupts to the system.

Implication: If the Clockrun protocol is used, the PCI clock can be shut down during modem sessions. In this case, the modem interrupt is not propagated through the 82559 to the Interrupt A pin.

Workaround: Three possible workarounds for this anomaly are listed below:

1. Disable the Clockrun signal during modem use.
2. Drive the Clockrun signal directly from the modem using external circuitry.
3. Drive the Interrupt A pin directly from the modem.

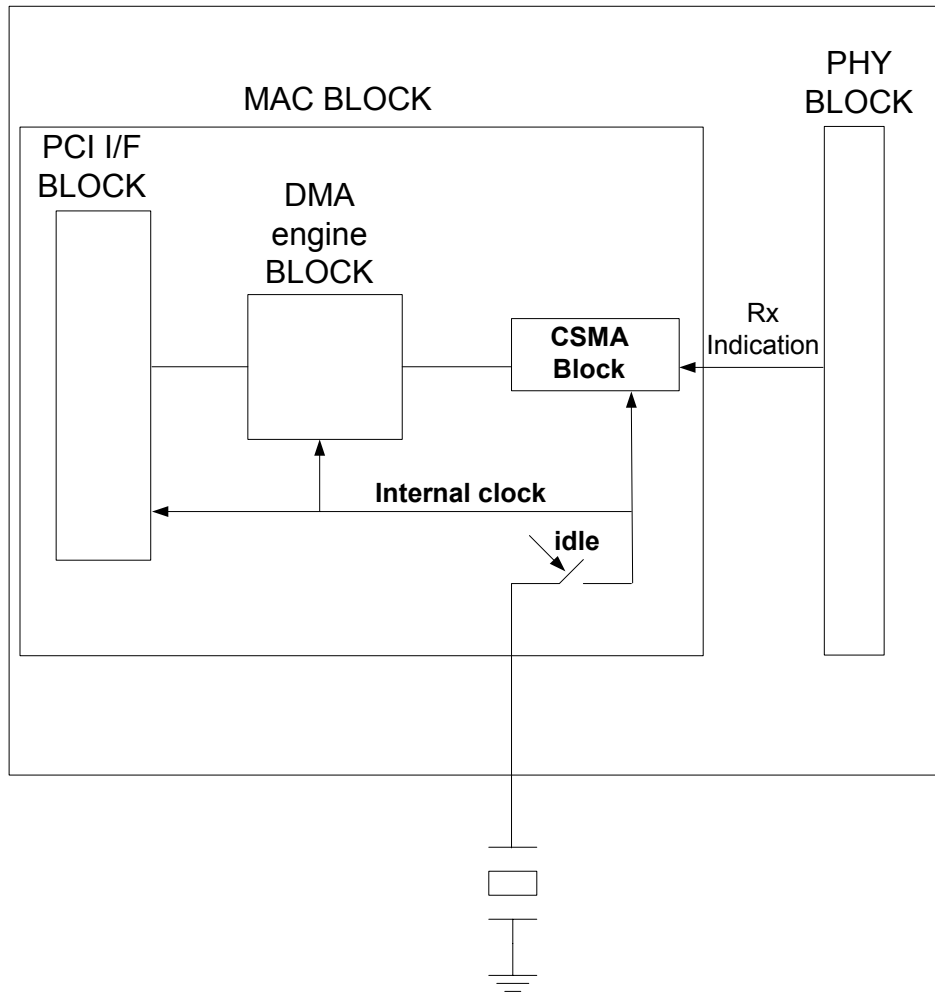
In Dynamic Standby mode, a possible synchronization condition may occur preventing the device from waking up when it receives an incoming frame. If this happens, the frame is not properly handled and is lost.

When the 82559 (B-step) is in the Dynamic Standby mode, clock signals to the MAC are stopped. Any received packet that passes address filtering causes the MAC block to wake up. The MAC block wakes up in a specific timing window by synchronizing between a recovered clock and

internal generated clock. A synchronization problem occurs between the recovered clock and internal generated clock. This window in which the problem can occur is identified as approximately 20 clocks at the beginning of the reception of a packet.
