MOTOROLA

Order this document by
MC68360UM/AD

MC68360

Errata and Added Information to **MC68360 Quad Integrated Communication Controller User's Manual Rev 1**

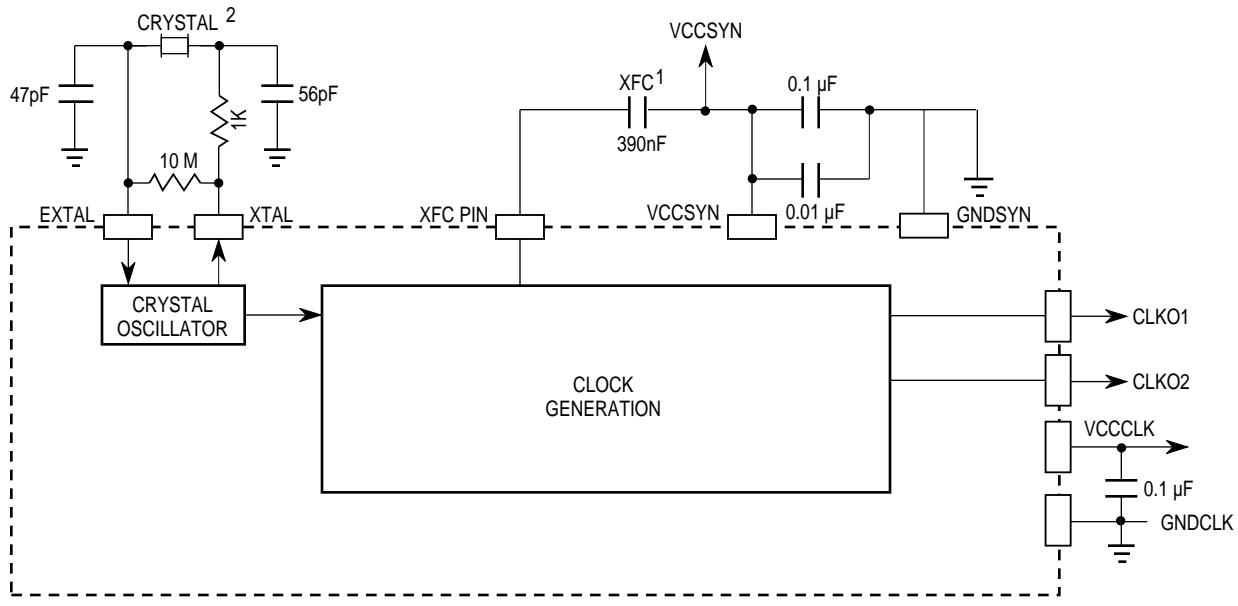
Figure 6-6A External Components for 4.192MHz

1. Must be low-leakage capacitor. See Section 10 Electrical Characteristics for recommended values.
2. Values are for 4.194MHz crystal and may vary due to capacitance on PCB.

Also on page 6-14 the following figure should be added.

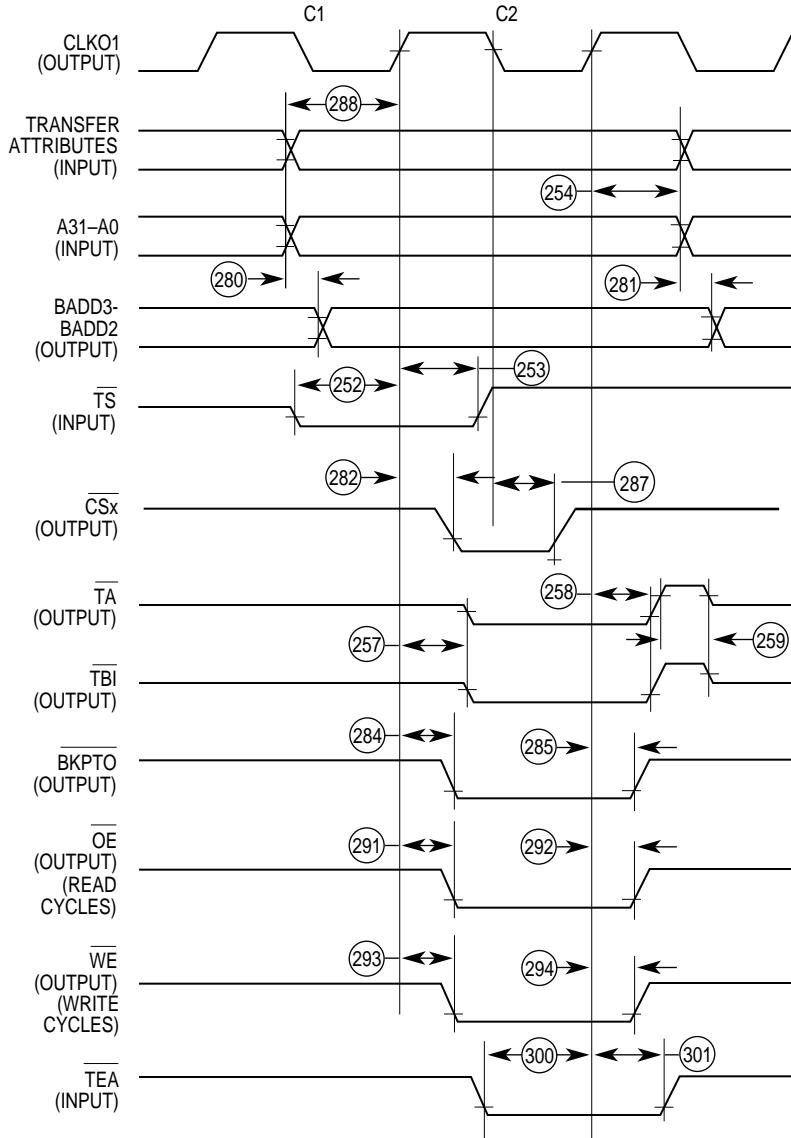
Figure 10-44(b) MC68040/EC040 SRAM Write cycle (TSS40=0, CSNT40=1)

NOTE: MC68040 Transfer Attribute Signals = SIZx, TTx, TMx, R/W, $\overline{\text{LOCK}}$

The following figure should be added after figure 10-44(a)

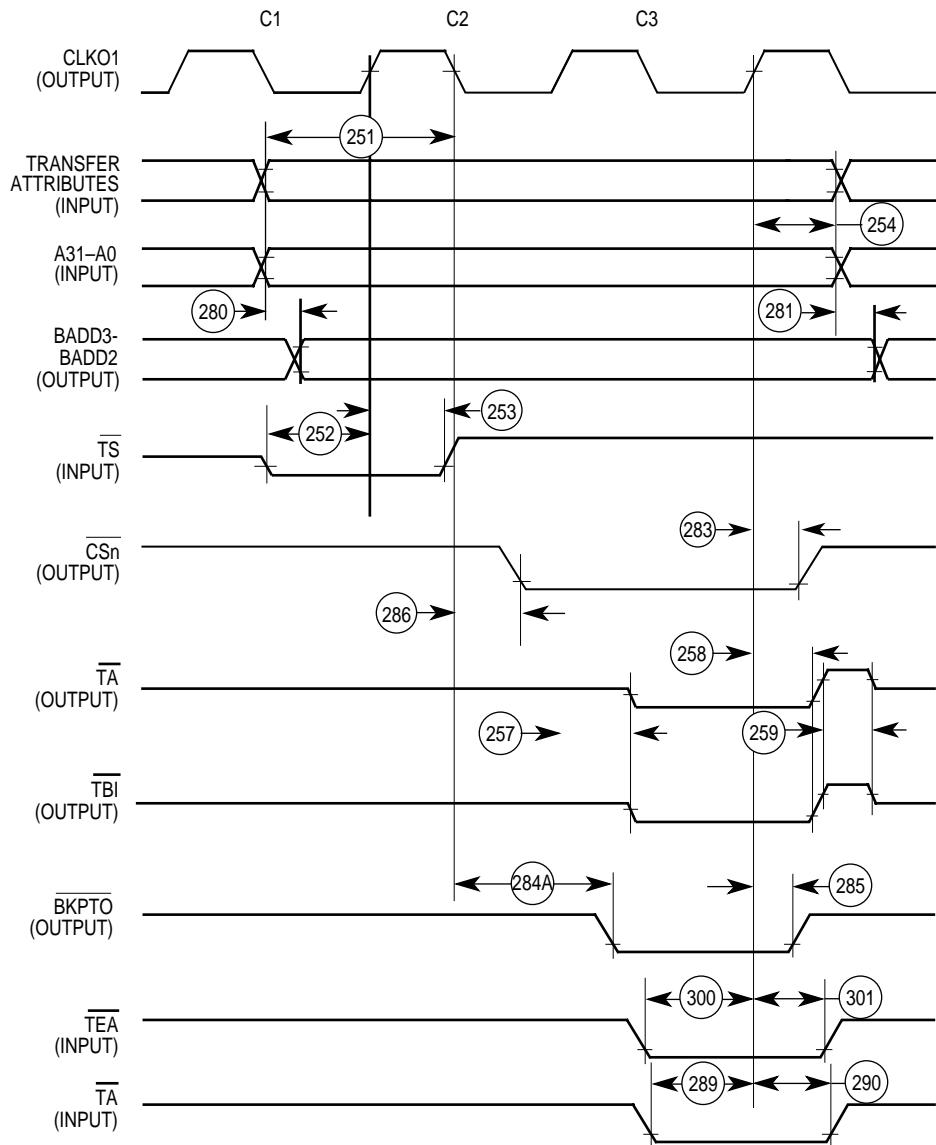
Figure 10-45(b) MC68040/EC040 SRAM Read Cycle (TSS40=1, CSNT40=1)

NOTE: MC68040 Transfer Attribute Signals = SIZx, TTx, TMx, R/W, \overline{LOCK}
 \overline{OE} and \overline{WE} are not supported when TSS40 is set to 1

The following figure should be added below figure 10-45(a)
