**PM73123**

**AAL1GATOR-8**

**REVISION A DEVICE ERRATA**

**ISSUE 1: FEBRUARY 2001**

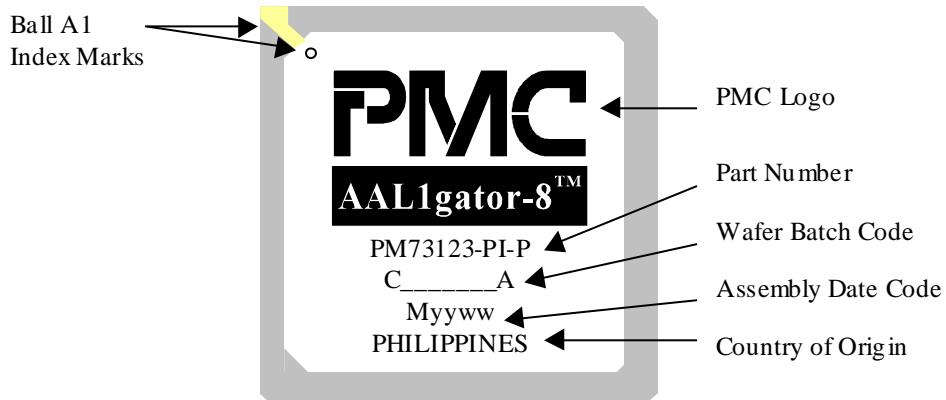
**Figure 1. PM73123 AAL1gator-8 Branding Format.**

The device revision code is marked at the end of the Wafer Batch Code on the face of the device (as shown in Figure 1). The PM73123-PI is packaged in a custom 324 PBGA, with a 23 x 23 mm body size, and a ball pitch of 1.00 mm.
