PM7380 FREEDM-32P672

REVISION B DEVICE ERRATA

Issue 2

March 2000

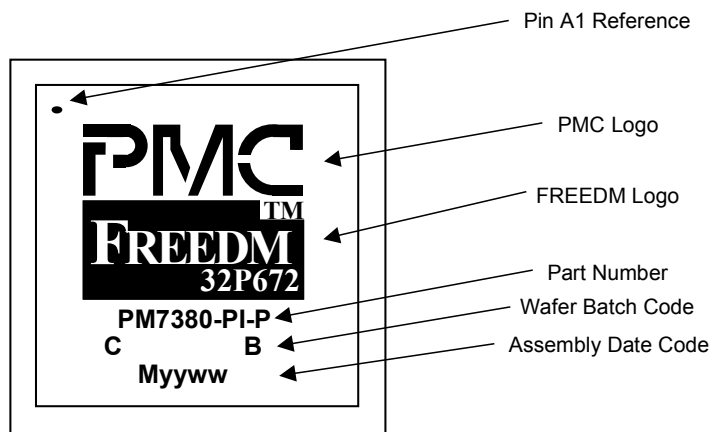
Figure 1.1: PM7380 FREEDM-32P672 Branding Format.

The information contained in Section 2 relates to Revision B of PM7380 FREEDM-32P672 only. The device revision code is marked at the end of the Wafer Batch Code on the face of the device (as shown in Figure 1.1). PM7380 FREEDM-32P672 Revision B is packaged in a 329-pin Plastic Ball Grid Array (PBGA).

Not to Scale
